## LOST MAN CREEK

### 6.7 Lost Man Creek Segment 1: From confluence with Jack Creek to Roaring Fork river.

### **Lost Man Creek Segment 1, Reach 1.**

## Roaring Fork Mainstem Segment 1, Reach 2.

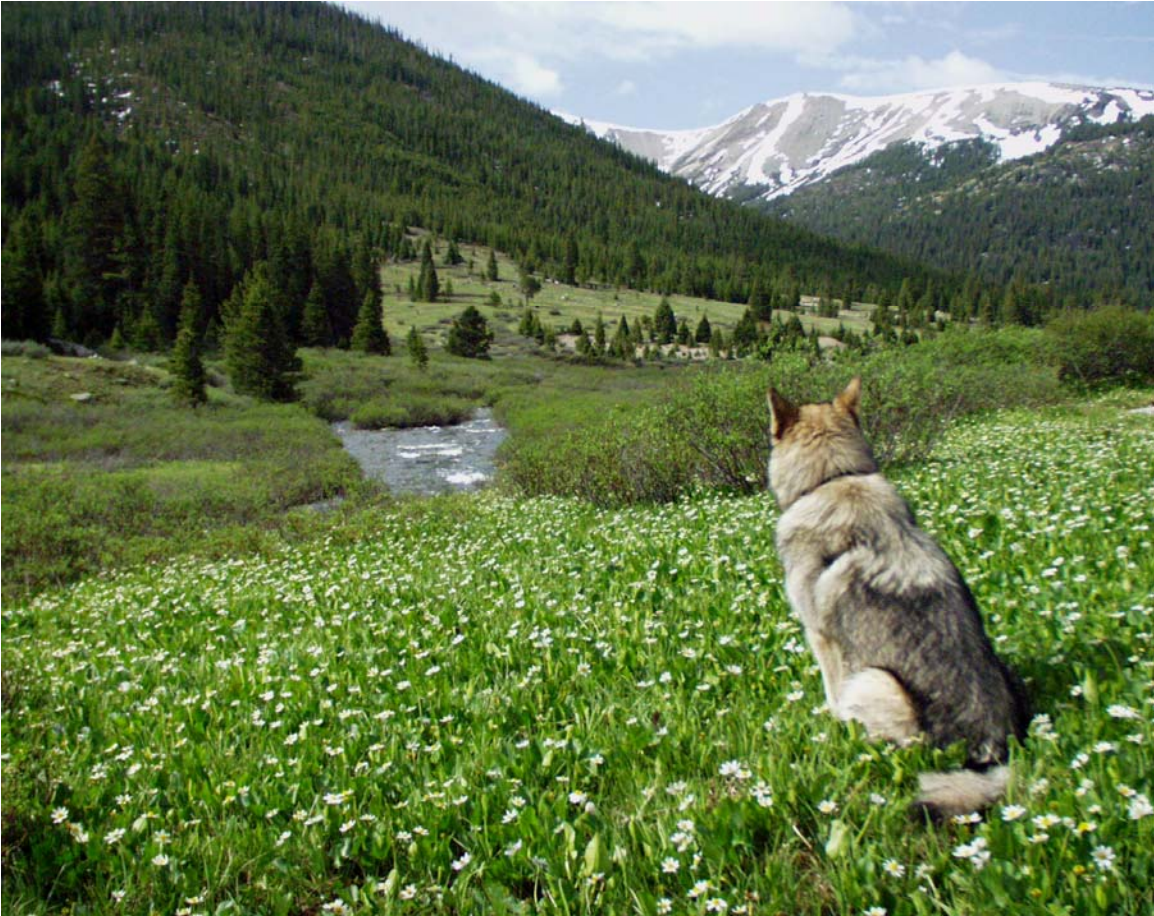
### Lost Man Creek.

Lost Man Creek headwaters in the Hunter Fryingpan Wilderness of the White River National Forest. Lush willow carrs characterize the valley floor and provide breeding habitat for Wilson's warblers, fox sparrows, Lincoln's sparrows and more. The willow carrs are sustained by overbanking flows during spring snowmelt and by soil moisture from upland snowmelt later in the season. A reservoir, dam and a diversion canal interrupt this natural flow before the stream reaches the Roaring Fork River. Above the reservoir a natural hydrologic regime sustains the stream-riparian ecosystem. Below the dam stream width and depth is decreased, and vegetation is encroaching into the stream channel with little habitat available for aquatic wildlife.

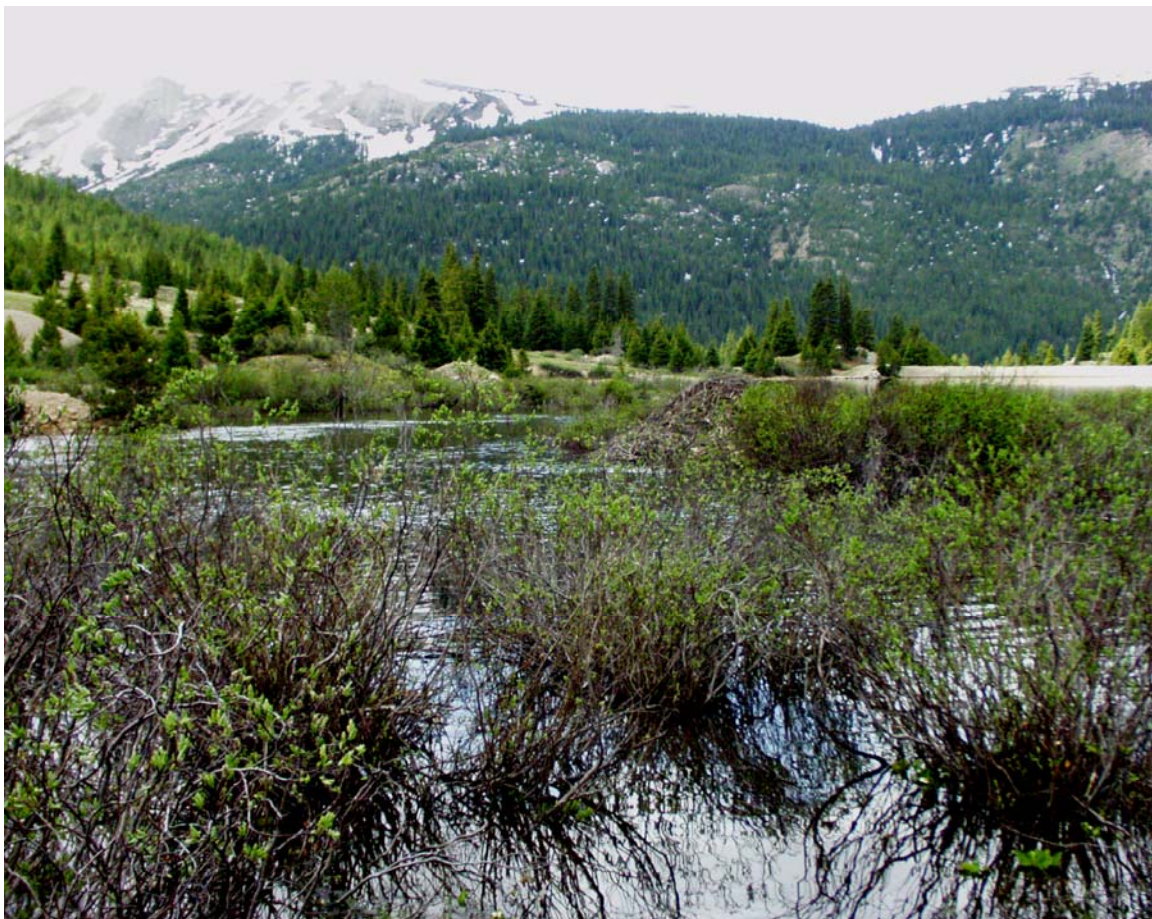
**Beaver activity enhances overbanking into the floodplain and water storage for release during low-flow season thus helping to maintain in-stream flows. Slowing of flood water also allows sediment to drop out of the water column resulting in both enhanced water quality and soil building.**

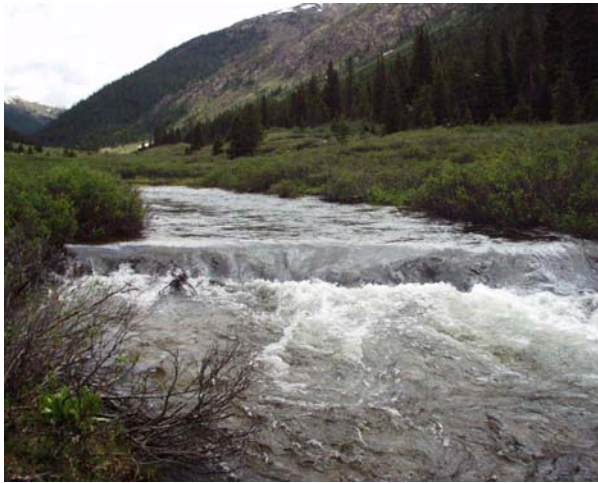
A beaver dam across the stream enhances energy dissipation and overbanking thereby increasing soil moisture that supports riparian vegetation.

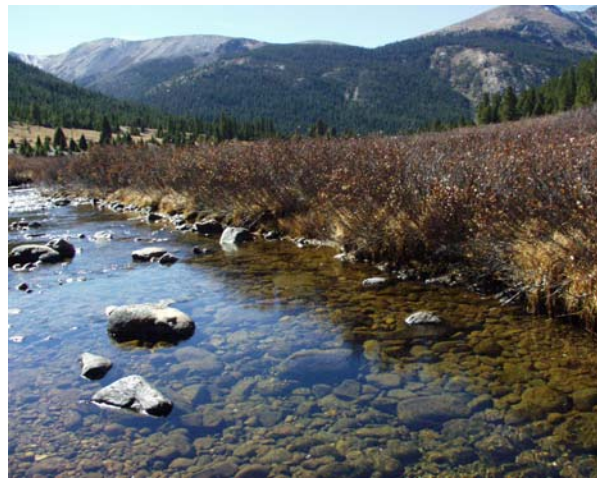
Even during low-flow season the stream channel remains full and thus provides adequate habitat for aquatic wildlife.

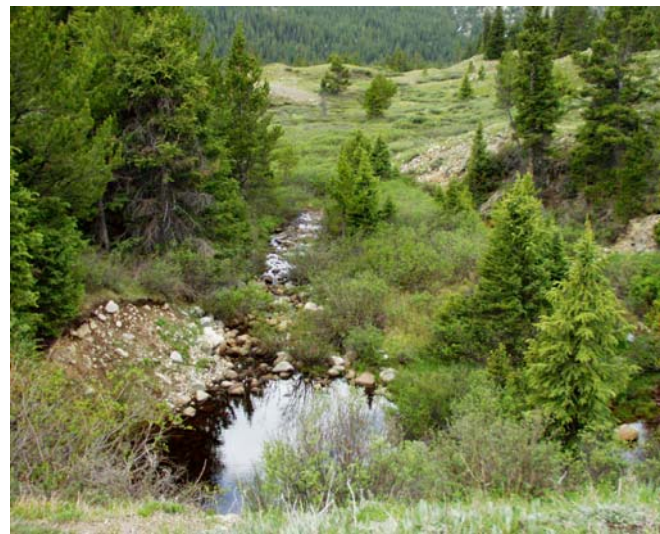
**Looking downstream from the top of the dam: A few hundred meters below the dam ground water discharge flows into Lost Man Creek.**

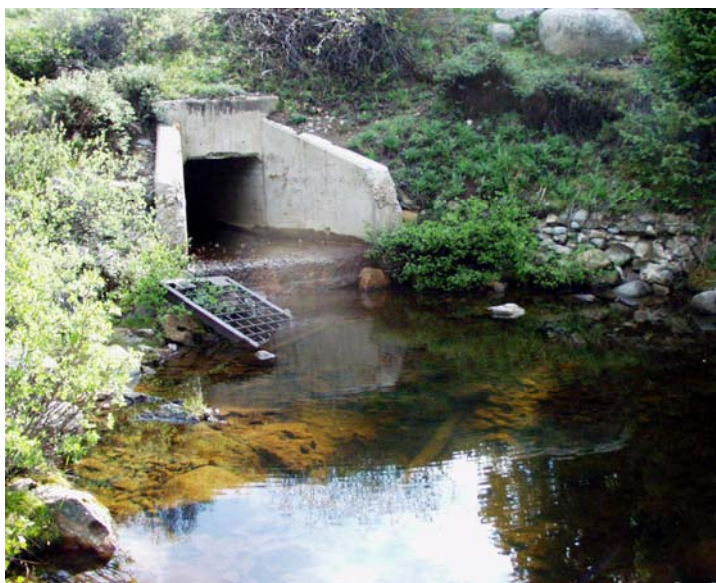
*Channel Condition:* Severe channelization occurs due to impacts from a reservoir, dam and a diversion. Dewatering of this reach has resulted in a lack of flow diversity, channel narrowing, and vegetation encroachment into the channel. Additionally a footbridge and a highway bridge contribute, although relatively minimally, to channelization.

**Below the dam, only leakage from the dam is allowed to flow back into the stream.**

- Restore natural hydrologic flow regime.
- Discontinue stocking the reservoir with non-native fish species.
- Remove non-native fish and restore native cutthroat.

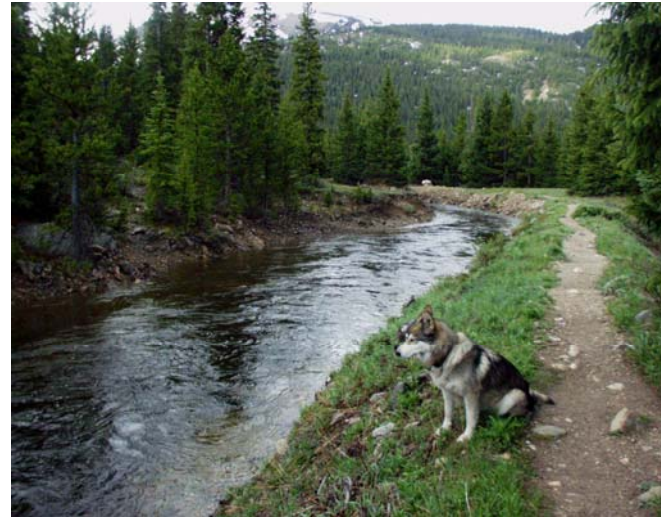
**This diversion ditch diverts all flows, except that which leaks through the dam, to the Front Range via the Twin Lakes tunnel.**

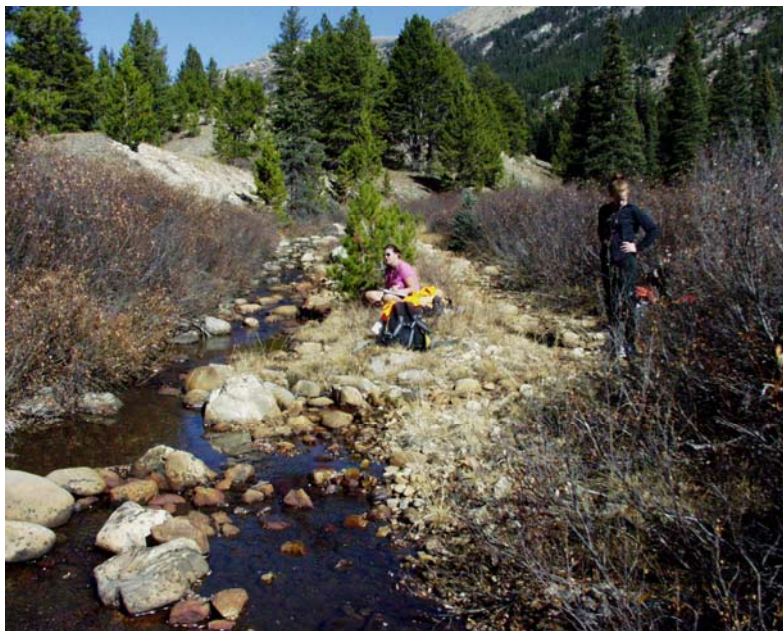
**During low flow season, there is minimal soil moisture discharge to fill the channel or maintain sustainable flows. Tina Palmer (left), botanist, is evaluating habitat structure while Cheryl Malone helps with data collection.**

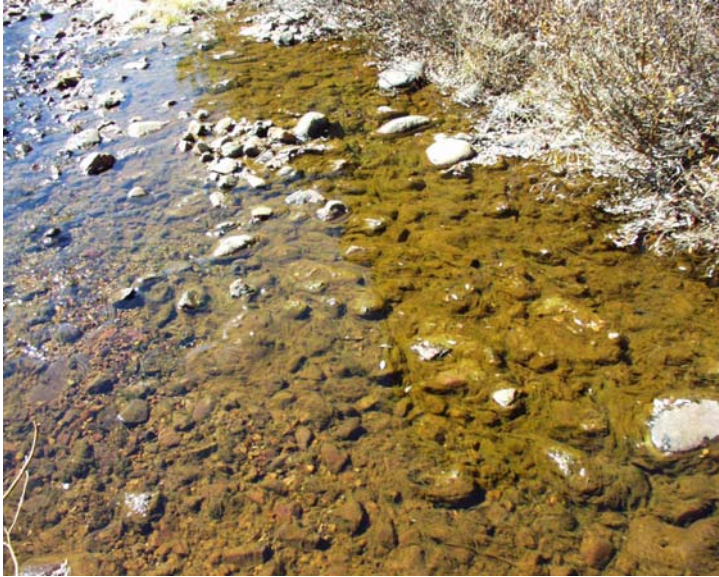
- Undersides of cobble substrate were black indicating probable anoxic environmental conditions and habitat impairment.

An orange sludge covers stream substrate up to a depth of 1 dm.
