CATALOG OF STREAM AND RIPARIAN HABITAT QUALITY FOR THE ROARING FORK RIVER AND TRIBUTARIES, CENTRAL COLORADO

Delia G. Malone and John C. Emerick
Roaring Fork Stream Health Initiative

Project Summary

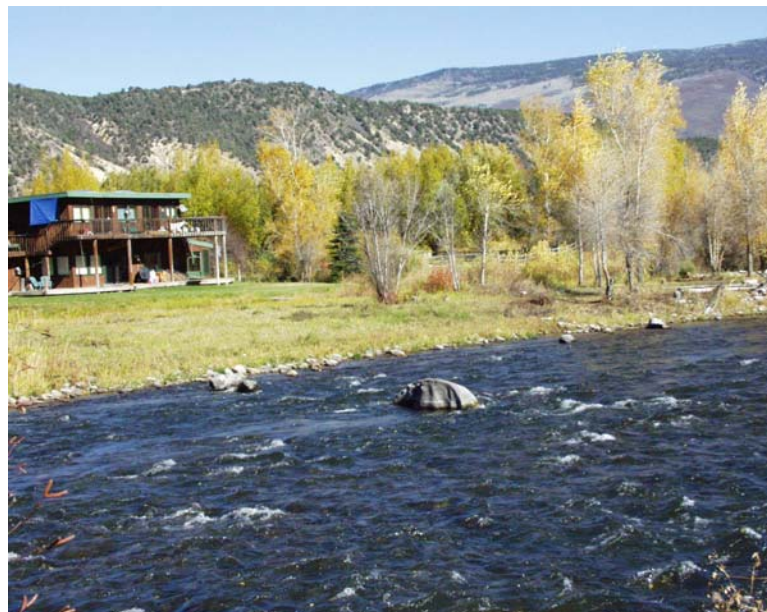
Rural housing development has frequently included removal of riparian vegetation, which has resulted in bank erosion and stream degradation.

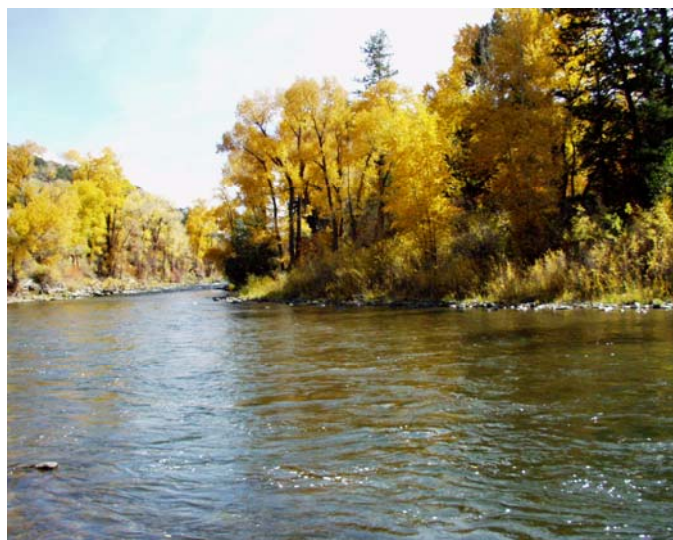
In spite of intense land development pressure, there are still areas where healthy riparian habitat survives, such as here near El Jebel. In places like this, stable stream banks have a beneficial effect on fish habitat, and the riparian vegetation provides diverse habitat for birds and other wildlife.

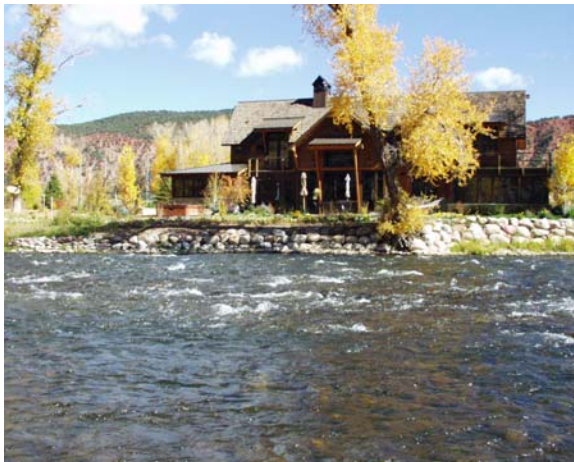
Vegetation removal in this golf community has destabilized stream banks, reduced shade that maintains cooler water temperatures and eliminated both aquatic and riparian wildlife habitat. Boulder rip-rap on the banks channelizes stream energy toward the next unprotected area downstream.

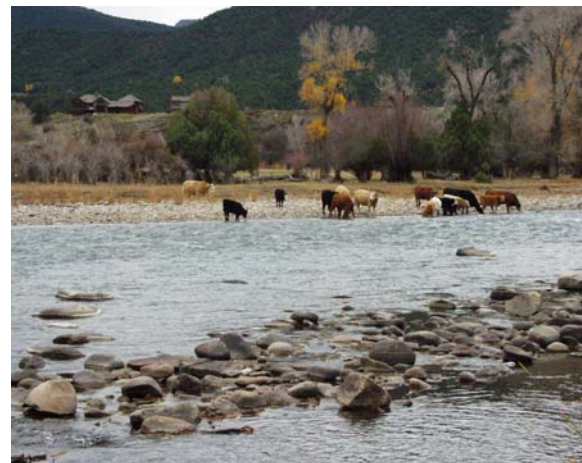
Cattle degrade water quality and destroy riparian habitat. Some of the ranches in the valley fence their livestock out of the riparian zone and allow access to water only at specific places, which results in a much healthier river system.
